**Research Paper**

**Site Observations on Buildings' Performance in Hatay Province  
After Kahramanmaraş Earthquakes**

Vail KARAKALE<sup>1a</sup>, Evren ÖZGÜR<sup>1b\*</sup>, Şenol ATAÖĞLU<sup>2c</sup>

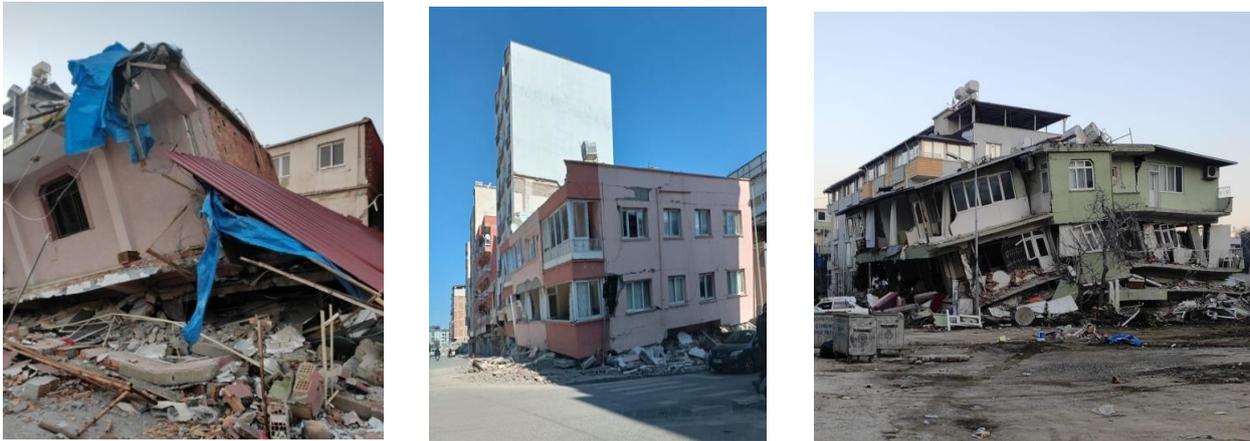
a) soft story, low concrete quality and poor reinforced detailing

The main causes of earthquake damage to these old buildings are having very low-quality concrete, poor reinforcement detailing, poor workmanship in concrete work, and deficiencies in the structural system (Figs. 8a and 8b). Some of these old buildings were constructed very close to each other without paying attention to floor diaphragm levels even for adjacent buildings, that's why they suffered pounding as it is shown in Fig. 8b. The lateral load structural systems of these buildings are generally RC frames with very low rotational ductility. Brittle partitioning walls in these buildings were damaged during the earthquake because they are not flexible to match the relatively big story drifts. Furthermore, local failures in beam-column connections and buckling of reinforcement bars,

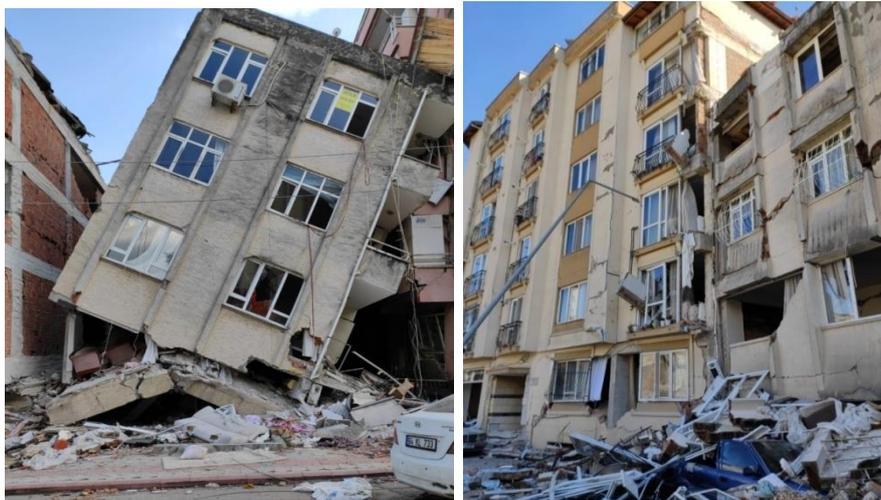
b) floors with different levels, pounding, and loss of bond between concrete and reinforcement bars

lack of adequate development lengths, and loss of bond between concrete and reinforcement bars were observed in these buildings (Fig. 8b).

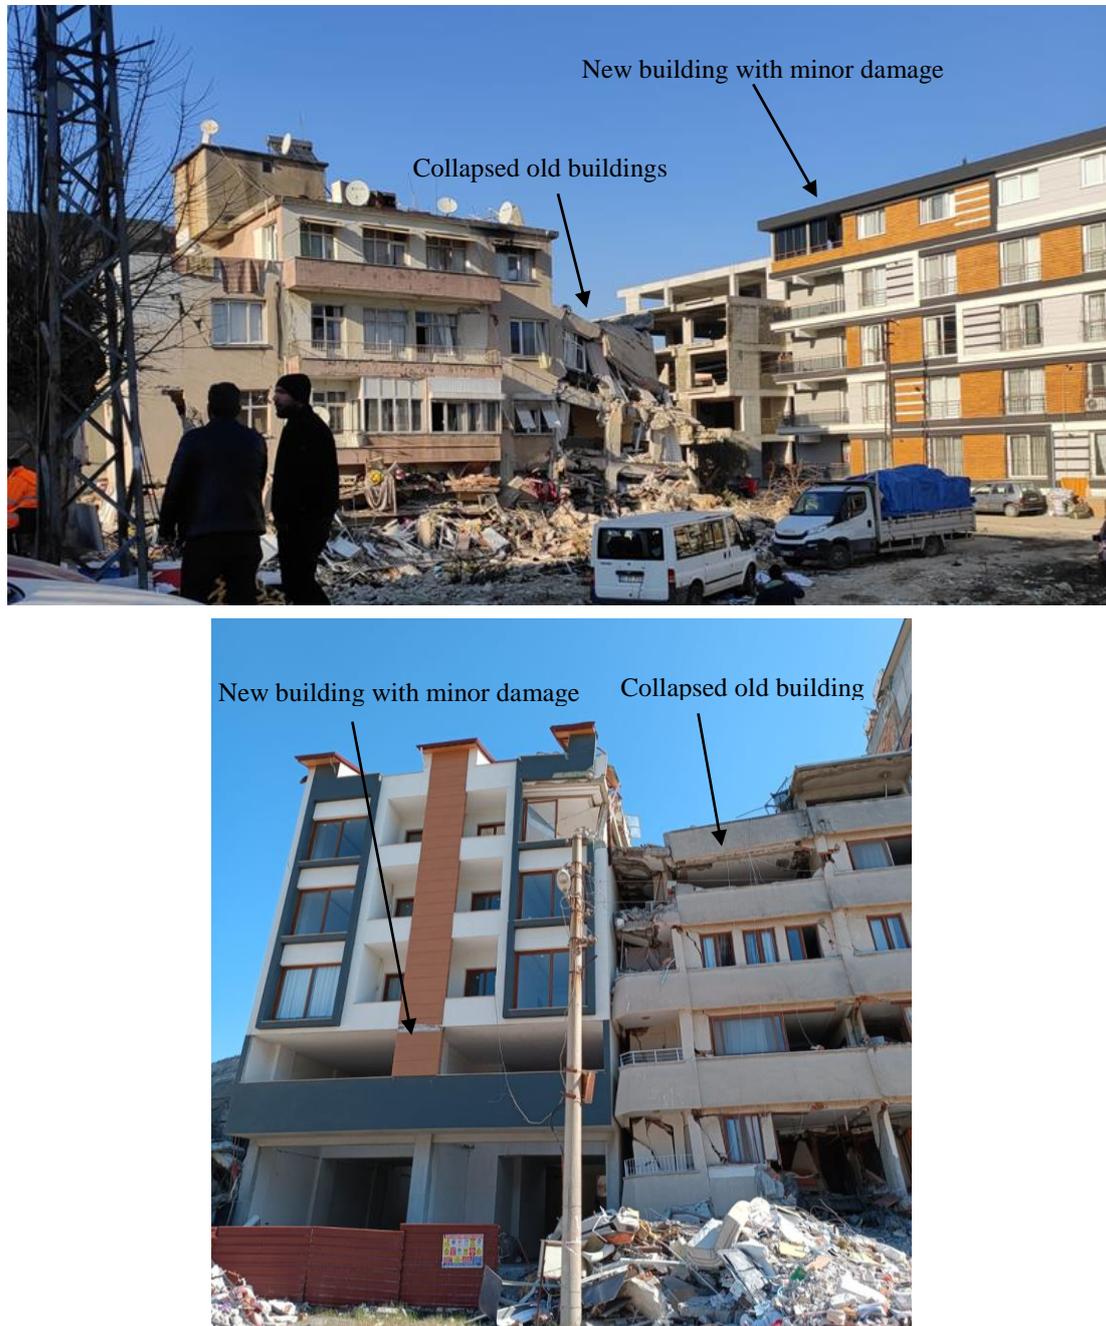
Fig. 9 shows a comparison of old and new buildings at the same site under the same soil condition. While old buildings collapsed, minor damage was observed in the new buildings in some areas.

**Figure 9.** The newly constructed buildings compared to the old buildings

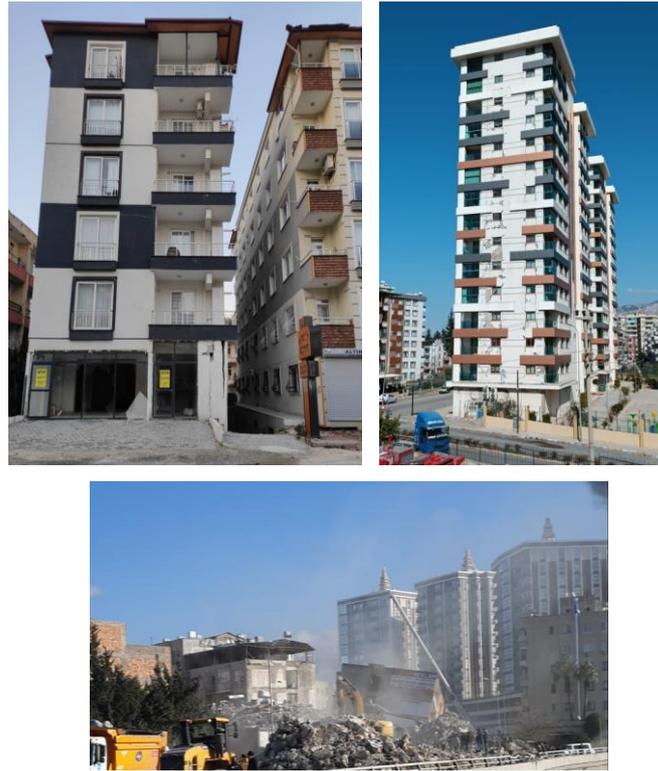
Some examples of new buildings are shown in Fig. 10. Most of the new buildings show good seismic performance with no damage or minor damage as seen in Fig. 10.

**Figure 10.** Good seismic performance of some new buildings

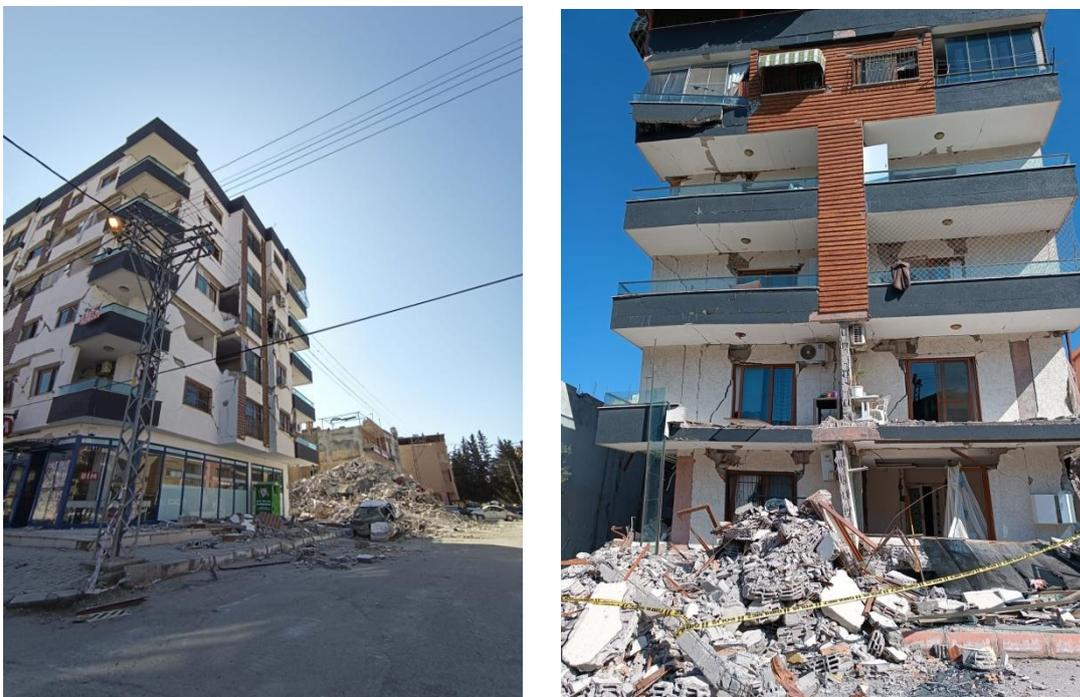
Fig. 11 shows examples of some new buildings with moderate and severe damage. Although these buildings have moderate and severe damage, they did not have pancake failure mode as it is shown in Fig. 11.

**Figure 11.** Damaged new buildings without pancake failure mode

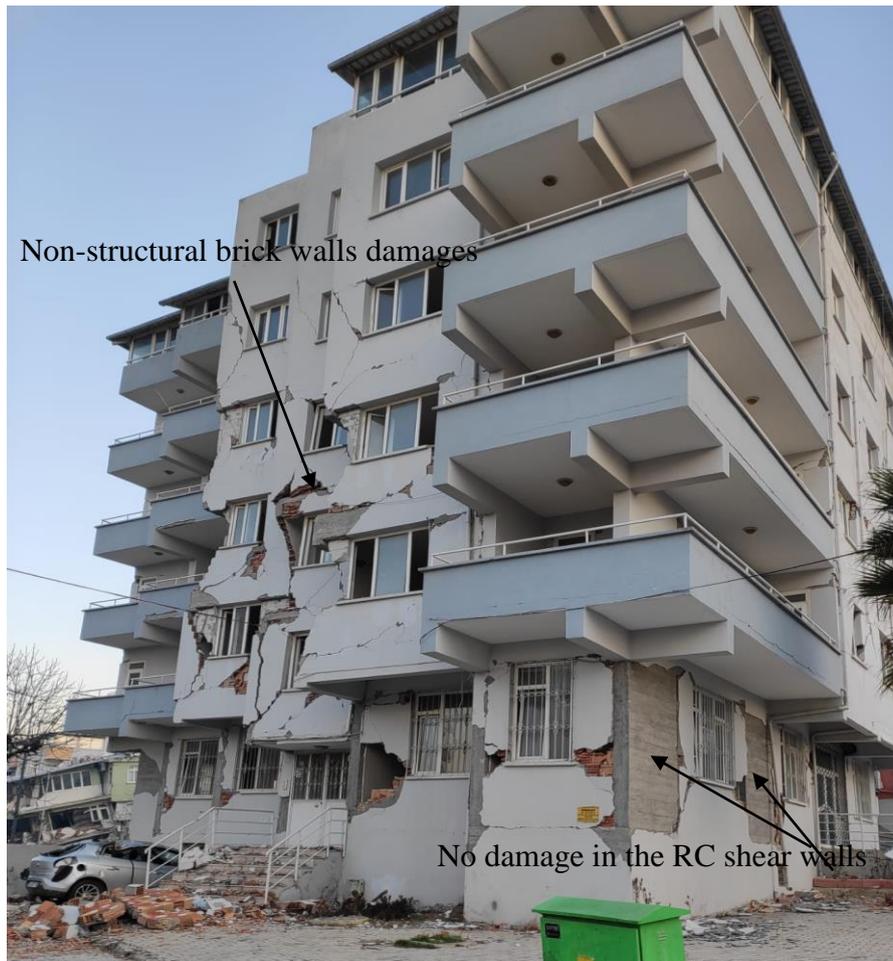
Buildings with RC shear walls show good performance even if they are old buildings as it is shown in Fig. 12.

**Figure 12.** An example of a building with RC shear walls

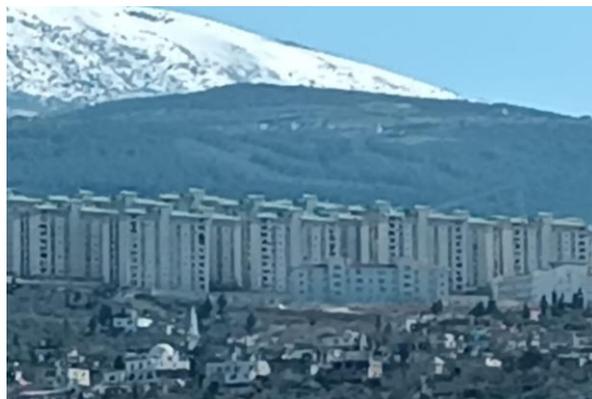
TOKI buildings constructed by the “Ministry of Environment, Urbanization, and Climate Change” in İskenderun show good seismic performance with minor or no damage. The structural system of TOKI company buildings is RC shear walls system, and the buildings were constructed on regions of stiff soils or rock soils (Fig. 13).

**Figure 13.** TOKI buildings in İskenderun without damage

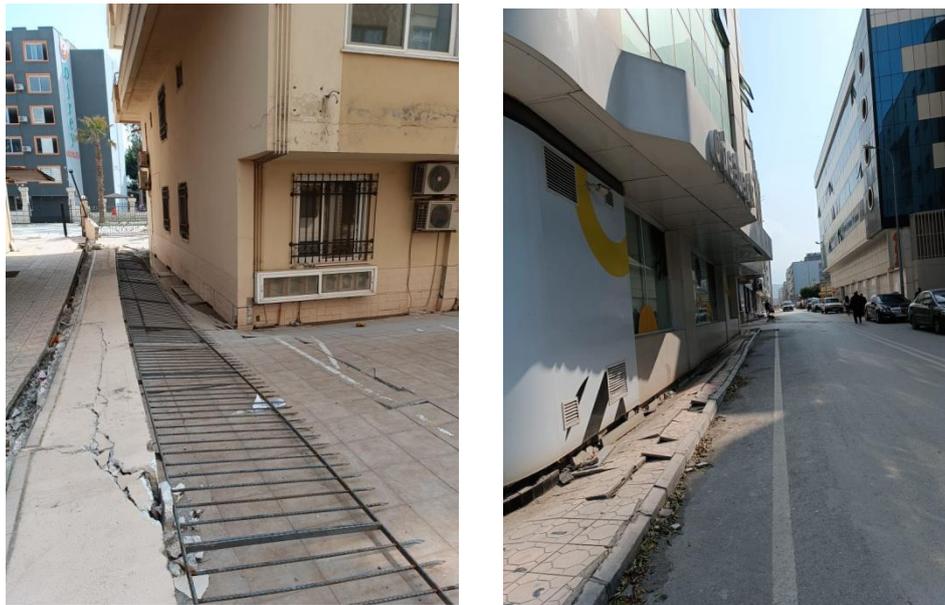
In some locations in İskenderun city, the earthquake causes soil liquidation which leads to buildings and road settlements as in is shown in Fig. 14.

**Figure 14.** Examples of soil liquefaction in İskenderun city
