**Research Paper**

**Site Observations on Buildings' Performance in Hatay Province  
After Kahramanmaraş Earthquakes**

Vail KARAKALE<sup>1a</sup>, Evren ÖZGÜR<sup>1b\*</sup>, Şenol ATAÖĞLU<sup>2c</sup>

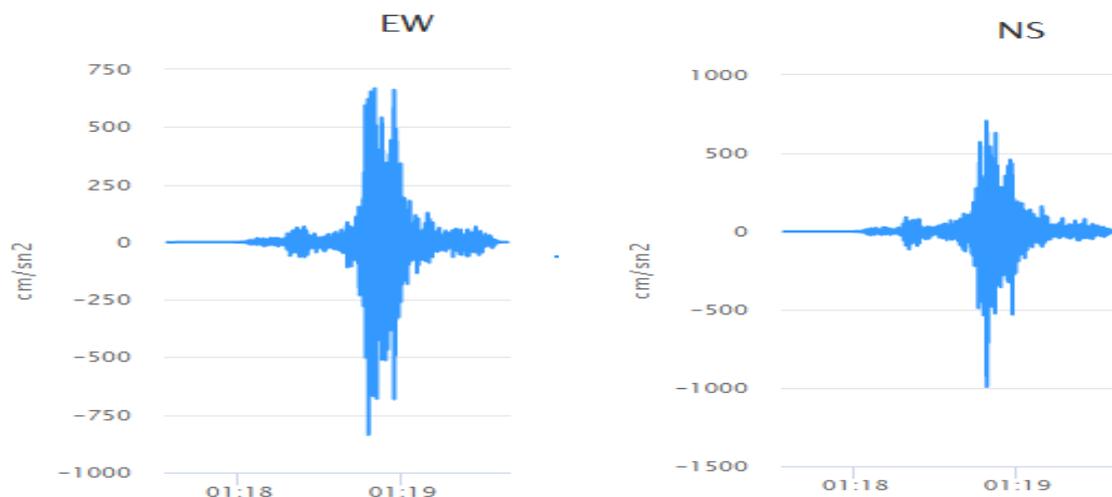
The 7.7  $M_w$  earthquake time history records for 3123 Antakya and 3112 İskenderun stations are shown in Figs. 3 and 4, respectively. As it is shown in Fig. 3 for Antakya, the earthquake lasted longer than one minute, and the east-west (EW) peak ground acceleration (PGA) value reached about 800  $\text{cm/s}^2$  which is 0.8 g.

**Figure 3.** 7.7  $M_w$  earthquake time history ground acceleration records at Hatay Antakya [9]

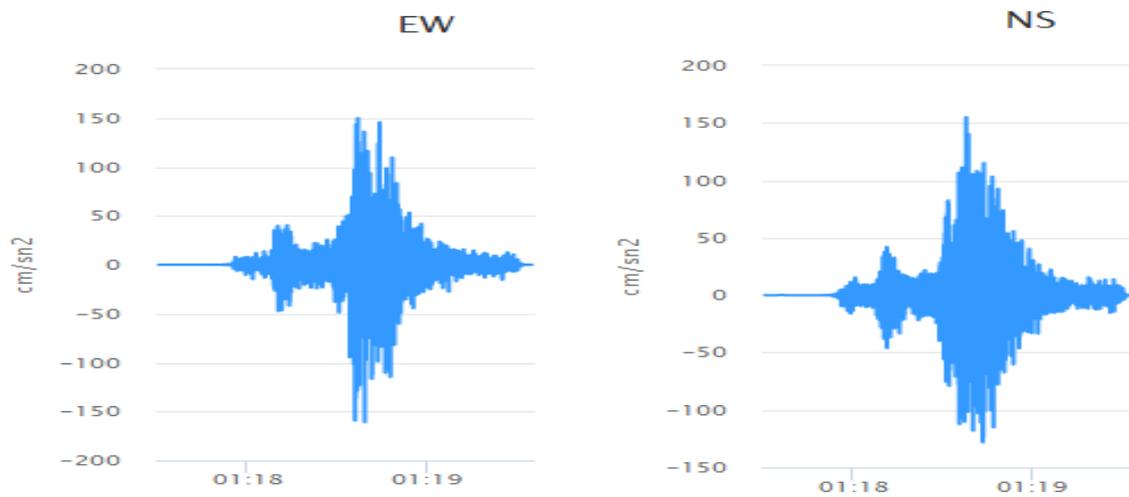
As seen in Fig. 4, the earthquake also lasted longer than one minute, and the east-west (EW) peak ground acceleration value reached approximately 200  $\text{cm/s}^2$  which is 0.2 g for İskenderun.

While comparing the PGA values of the earthquake for the two cities, it is clearly seen that the acceleration value of Antakya was more than 4 times higher than İskenderun.

**Figure 4.** 7.7 Mw earthquake time history ground acceleration records at Hatay İskenderun [9]

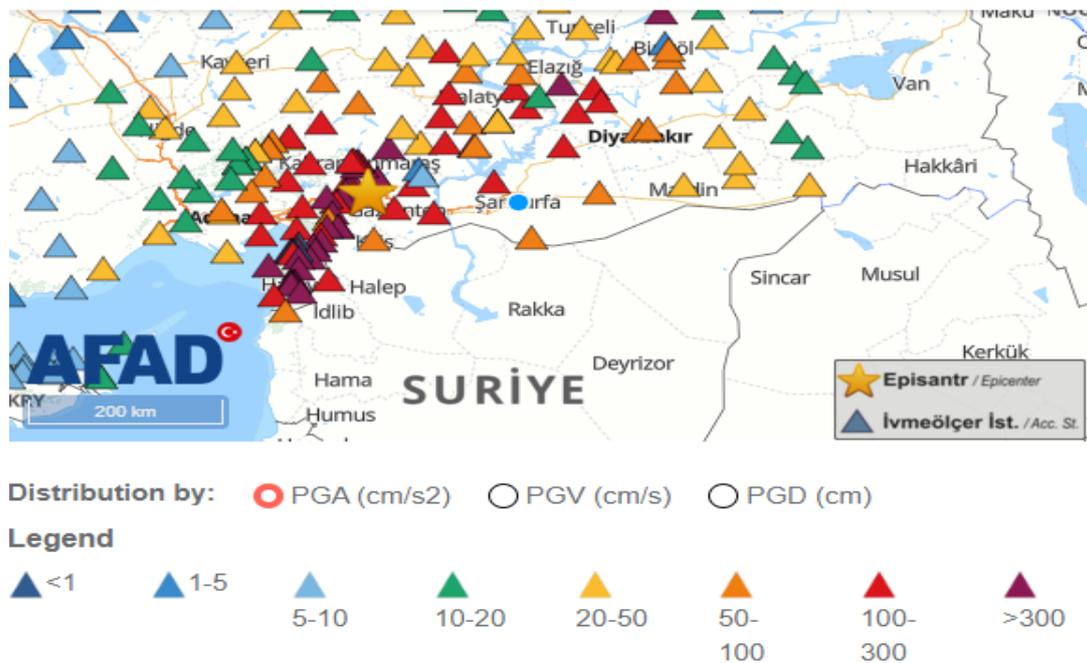
PGA values at different locations in Antakya and İskenderun cities were measured by AFAD seismic station and presented in Fig. 5 and Table 1. It is understood from the figure that, in Antakya city center, the PGA is very high with a value more than the value of the acceleration of gravity (that is more than one g), and the average value of the PGA in Antakya is about 0.86 g. Previous studies

showed that most of the settlements are located on the softest and soft soils [10]. Thus, these high PGA values occur due to the soft soil conditions which amplify the seismic waves.

**Figure 5.** PGA values of all stations for 7.7 Mw earthquake (AFAD)

Furthermore, in İskenderun, the average PGA value in most locations is about 0.2 g except in one location which is close to the highway road with a PGA of about 1.1 g. In addition, at this location, most of the damage occurred and this is the result of the soft soil condition there. In İskenderun, locations near the seaside have PGA with 0.17 g, and that’s why there is only minor damage, or no damage appeared at the buildings.

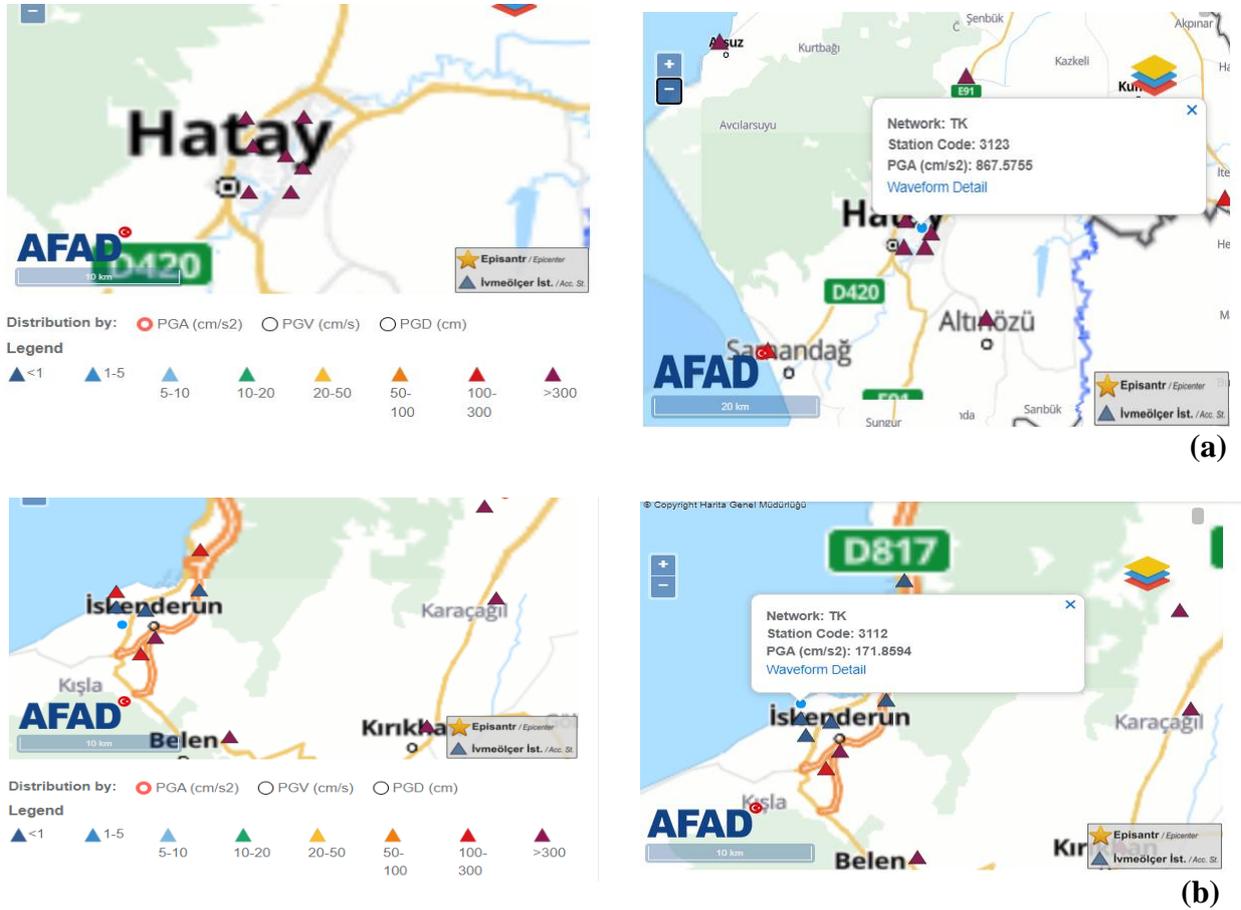
Figure 6. Two examples of PGA values, (a) 3123 Antakya and (b) 3112 İskenderun stations

Fig. 6 shows the PGA values for 3123 Antakya and 3112 İskenderun stations. It can be said that PGA values at Antakya are about four times higher than PGA values in İskenderun. Thus, the level of damage and number of buildings that collapsed in Antakya is about three or four times higher than the level of damage in İskenderun.

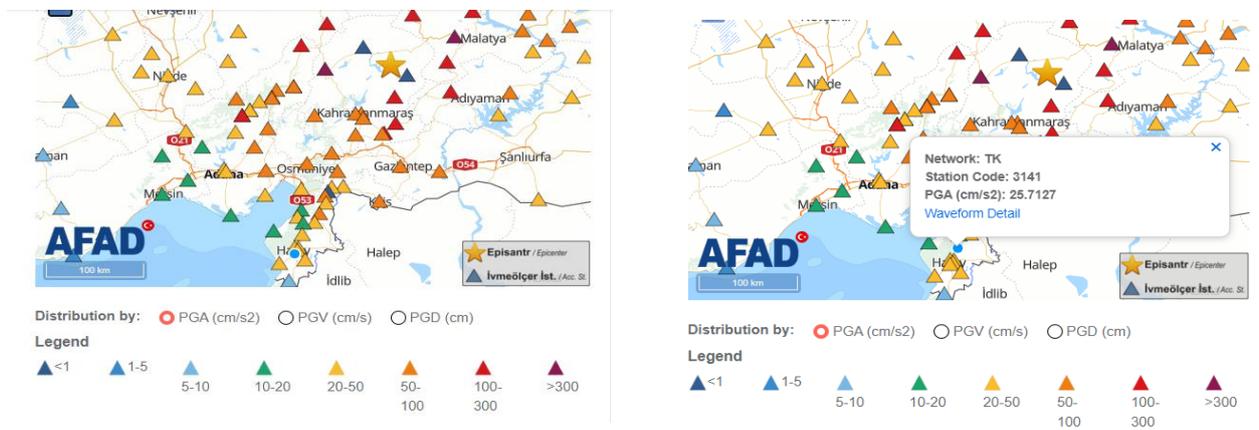
Fig. 7 shows the PGA values of all stations for the second earthquake which occurred at 13.24 local time. The fault line of that earthquake does not pass from Antakya. Therefore, the PGA value in Antakya is very low, measuring about 26 cm/s<sup>2</sup>.

Figure 7. PGA values of all stations for 7.6 Mw earthquake (AFAD)
